RAINBOW AIRCRAFT ADDRESS: Hangar 28, Springs Airfield, Dal Fouche, Springs, South Africa. Tel: 011 817 2298	SAFETY BULLETIN
NUMBER	TITLE
CH-11-08	Wing support strut brackets

Aircraft type	All Cheetah aircraft within serial number range identified below
Serial Nr	CH-088 through CH-097

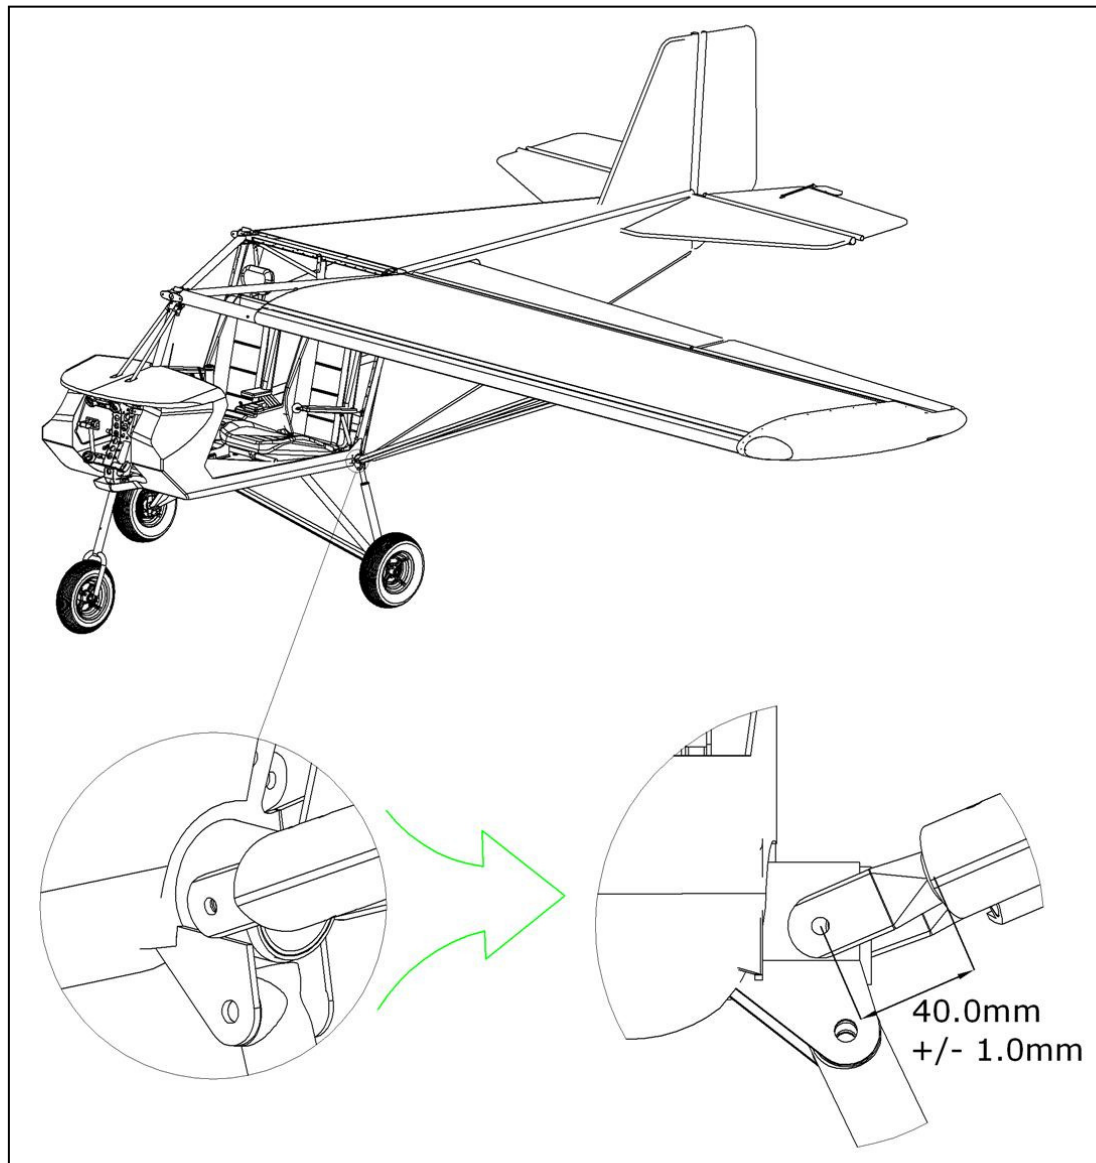
ANNEX A

Discovered possible deficiency in the manufacture on one batch of Wing Support Strut tubes

Note: Measure the distance from the centre of the Front wing strut mounting bolt to the edge of the wing strut. The distance should be 40.0mm +/- 1.0mm.

- 1) Inspect affected parts and ensure the distance as indicated in Annex A is correct.
- 2) Only Front Wing Support Strut tubes may be affected, on Left and Right hand sides.
- 3) If indicated distance is out of spec contact the factory to make arrangement for replacement of affected components.
- 4) Replacement of this part must be done by factory personnel only.
