Rainbow Aircraft (Pty) Ltd

SERVICE BULLETIN

IMPORTANCE	Before next flight
AREA AFFECTED	Flight controls
SB SERIAL NUMBER	Cheetah/001/09-2009

SUBJECT: Elevator control stick hinge bolt inspection.

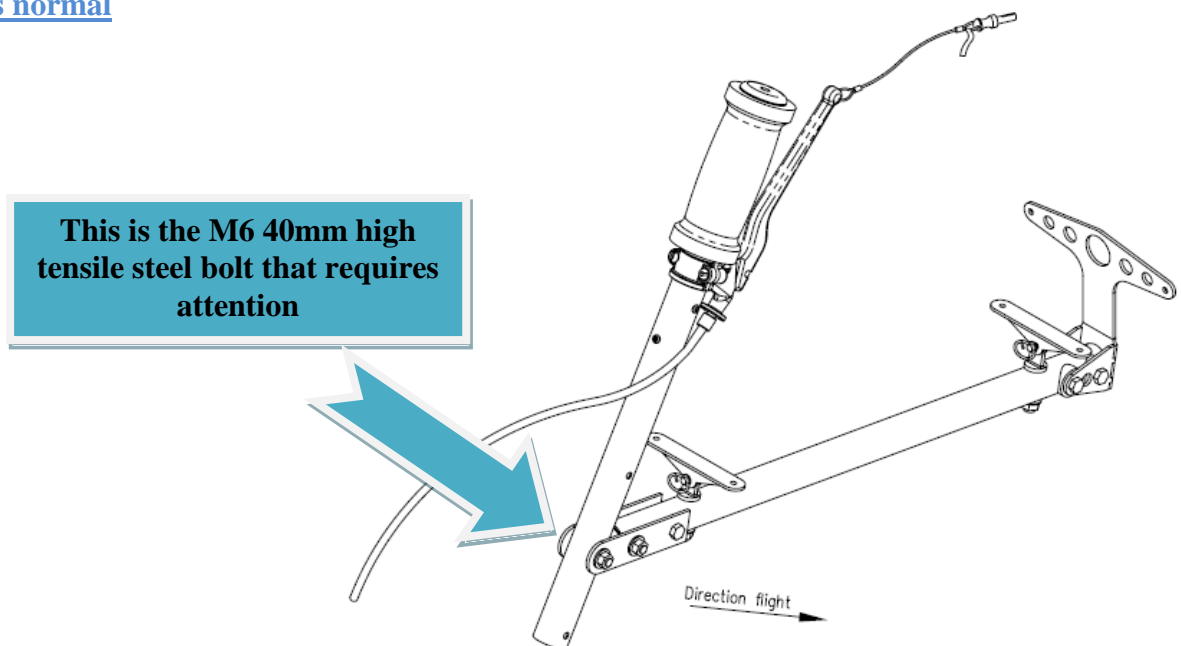
Rainbow Aircraft has recently conducted a 500 Hour inspection on a Cheetah XLS. During the process of replacing an Elevator cable, it was found that the Elevator / Aileron control stick in the flight deck had a small amount of play. On further investigation it was found that the M6 40mm 8.8 high tensile steel bolt used as the pivoting point for elevator control, has worn away to allow play to form. The bolt has been inspected to determine the severity of the defect. The bolt has been found to have eroded away due to friction. This friction is induced by the cable tension from the elevator cables. [This situation is normal](#)

Immediate compliance: Inspect the Elevator control stick, hinge bolt for erosion (wear) as per accomplishment procedures.

Long term compliance: Replace this hinge bolt every 500 hours.

4. Inspect for erosion (wear) in the circumference of the bolt shank.
The erosion (wear) will be in the form of grooves forming on both ends of the shank.
If the bolt shank is smooth with no defects or wear it can be re fitted.
If there are any defects the bolt must be replaced. (See replacement parts)
