# Rainbow Aircraft (Pty) Ltd

## **ALERT SERVICE BULLETIN**

<b>IMPORTANCE</b>	Critical
<b>AREA AFFECTED</b>	FLIGHT CONTROLS
<b>SB SERIAL NUMBER</b>	Cheetah/003/12-2009

**SUBJECT:** Elevator control arm and tie brace

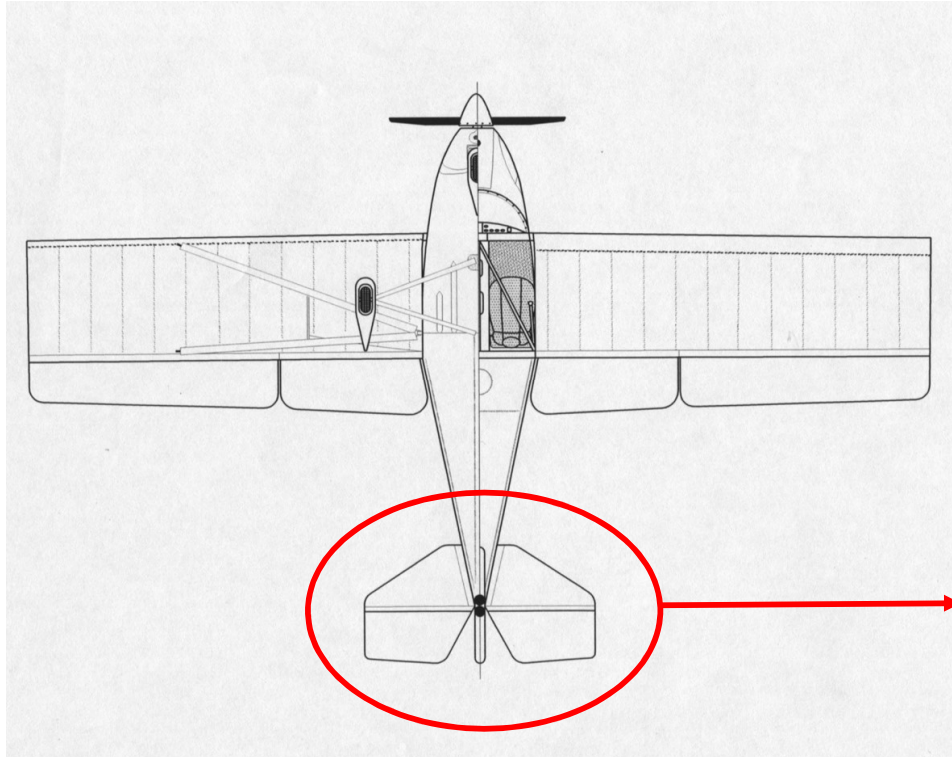
Cheetah/XL/XLS aircraft with old style (shape) Elevator (Highly advisable that all aircraft be inspected), as shown in figure below. The old style elevator puts more force on the tie rod flange than the new style.

**OLD STYLE  
(HIGHLY  
AFFECTED BY  
THIS SB)**

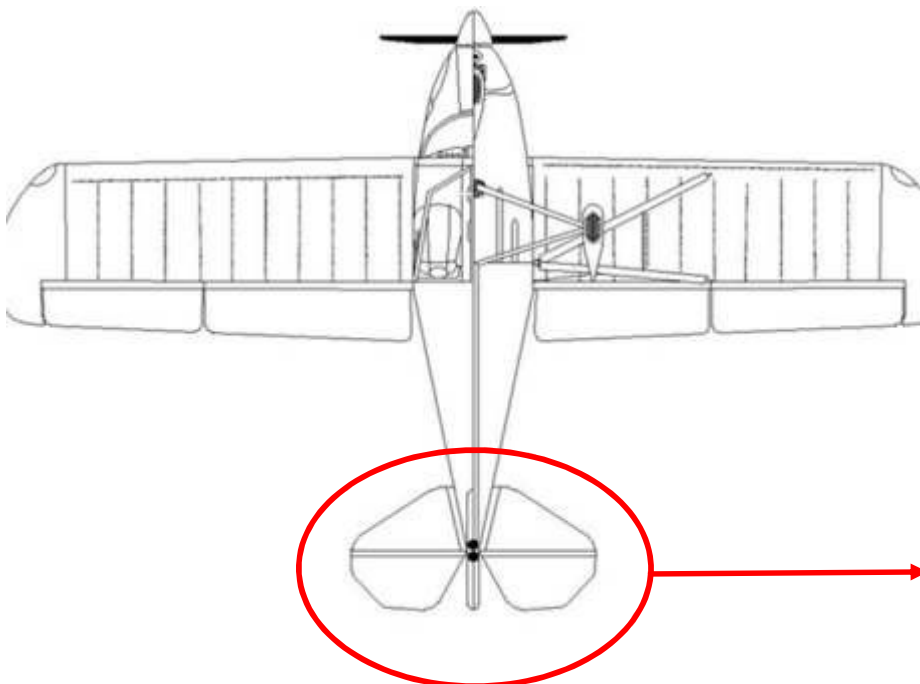
**NEW STYLE  
(NOT AS HIGHLY  
AFFECTED BY THIS SB)**

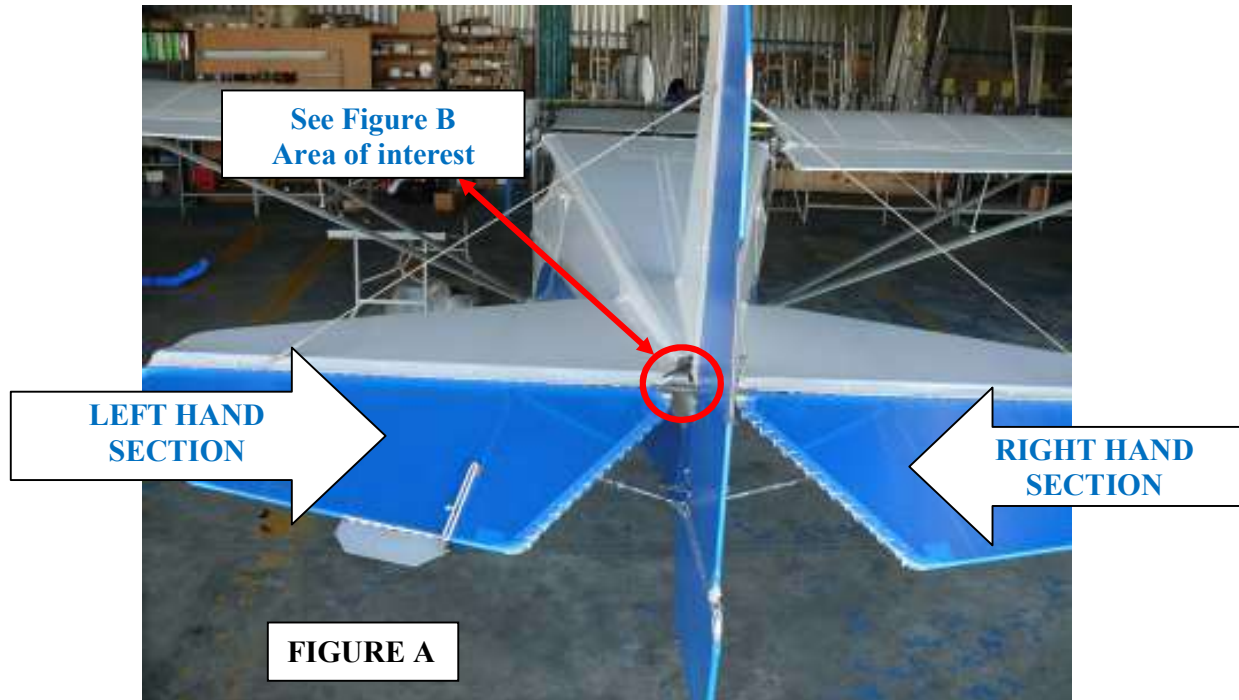
On a recent pre-flight inspection on an Cheetah XLS with the old style elevator, We have found that the tie bracket that connects the left hand section of the elevator to the right hand section (Figure A) of the elevator was cracked off.

Due to the amount of flight hours accumulated on this aircraft it was found that this tie point has cracked off because of fatigue.

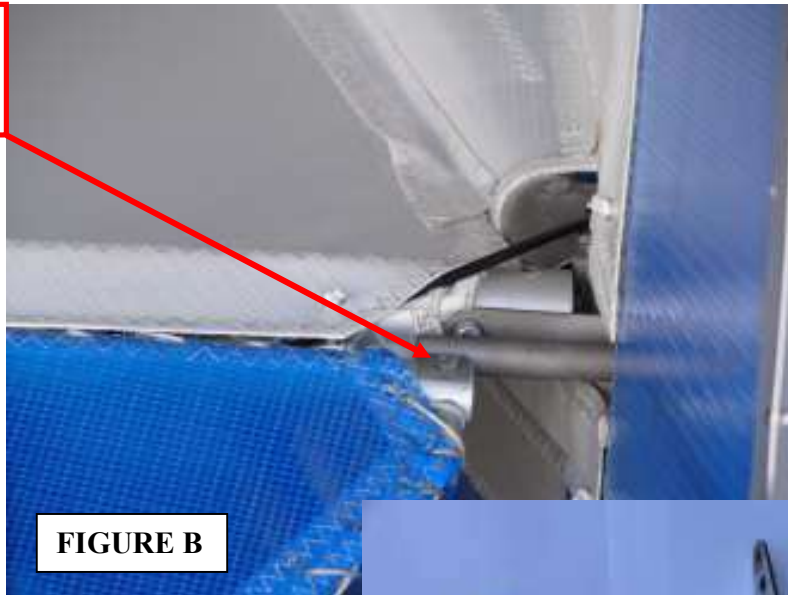
This is the area where the tie rod flanges cracked off.

This tie rod needs to be replaced with a newly designed tie rod as shown in figure C as indicated in paragraph 1d.

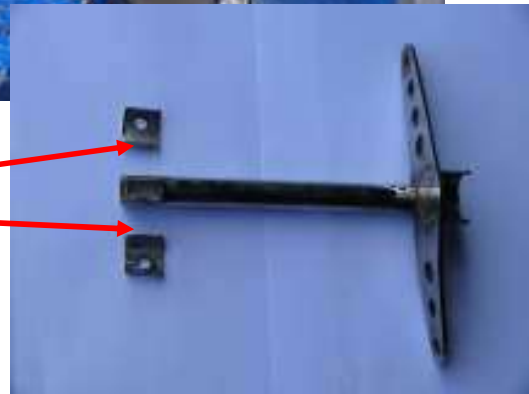
This is the area where the tie rod flanges cracked off.

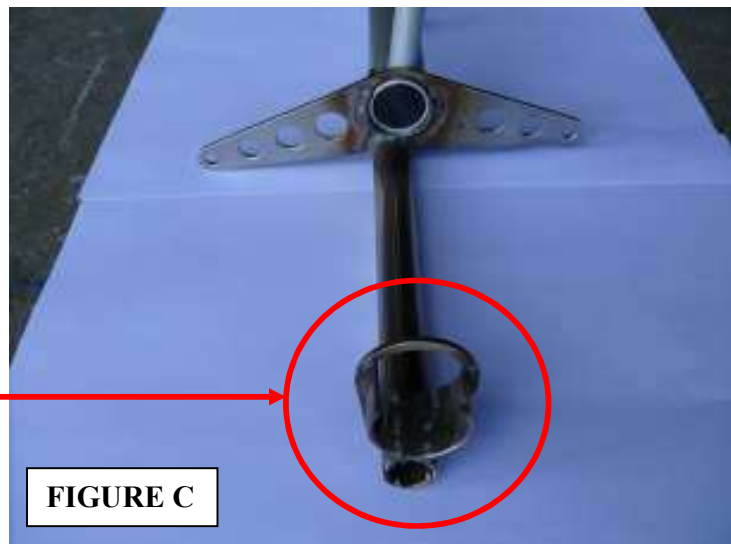
New design of attachment that must be replaced as soon as possible.

As per Figure C new remanufactured tie rod.
