Rainbow Aircraft (Pty) Ltd

SERVICE BULLETIN

IMPORTANCE	Before next flight
AREA AFFECTED	Flight controls
SB SERIAL NUMBER	Cheetah/001/09-2009

SUBJECT: Elevator control stick hinge bolt inspection.

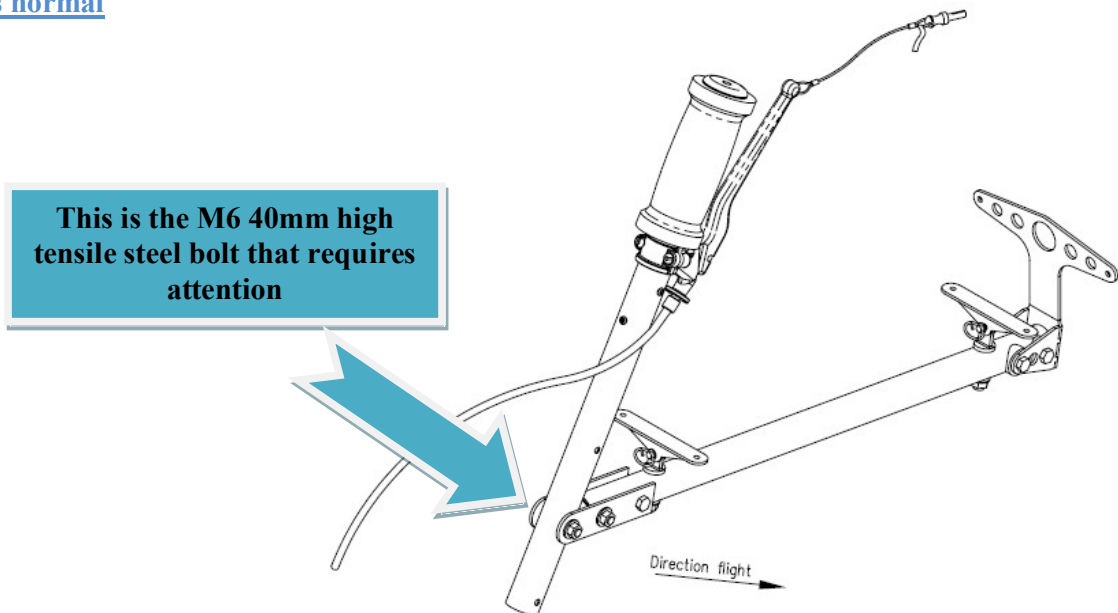
Rainbow Aircraft has recently conducted a 500 Hour inspection on a Cheetah XLS. During the process of replacing an Elevator cable, it was found that the Elevator / Aileron control stick in the flight deck had a small amount of play. On further investigation it was found that the M6 40mm 8.8 high tensile steel bolt used as the pivoting point for elevator control, has worn away to allow play to form. The bolt has been inspected to determine the severity of the defect. The bolt has been found to have eroded away due to friction. This friction is induced by the cable tension from the elevator cables. [This situation is normal](#)

The wear on the hinge bolt has been investigated by the Accountable Manager, Engineering department and Quality assurance. It has been concluded that the wear on this bolt is normal but needs attention. The procedure is to inform you, our valued customer, that there is a situation that you should give attention to, to assure the continued airworthiness and safety of your Cheetah Aircraft.

Immediate compliance: Inspect the Elevator control stick, hinge bolt for erosion (wear) as per accomplishment procedures.

Long term compliance: Replace this hinge bolt every 500 hours.

4. Inspect for erosion (wear) in the circumference of the bolt shank.
The erosion (wear) will be in the form of grooves forming on both ends of the shank.
If the bolt shank is smooth with no defects or wear it can be re fitted.
If there are any defects the bolt must be replaced. (See replacement parts)
