Rainbow SkyReach (Pty) Ltd

SERVICE BULLETIN

IMPORTANCE	HIGH
AREA AFFECTED	FUEL TANK INTEGRITY
SA/B NUMBER	CH 009-04-2019
EFFECTIVE DATE	18 APRIL 2019

Fuel tank inspection to ascertain if damage has been sustained by the fuel tank due to impingement of the seat backrest bolt on it with the passage of time, and if so ascertain the severity of the damage.

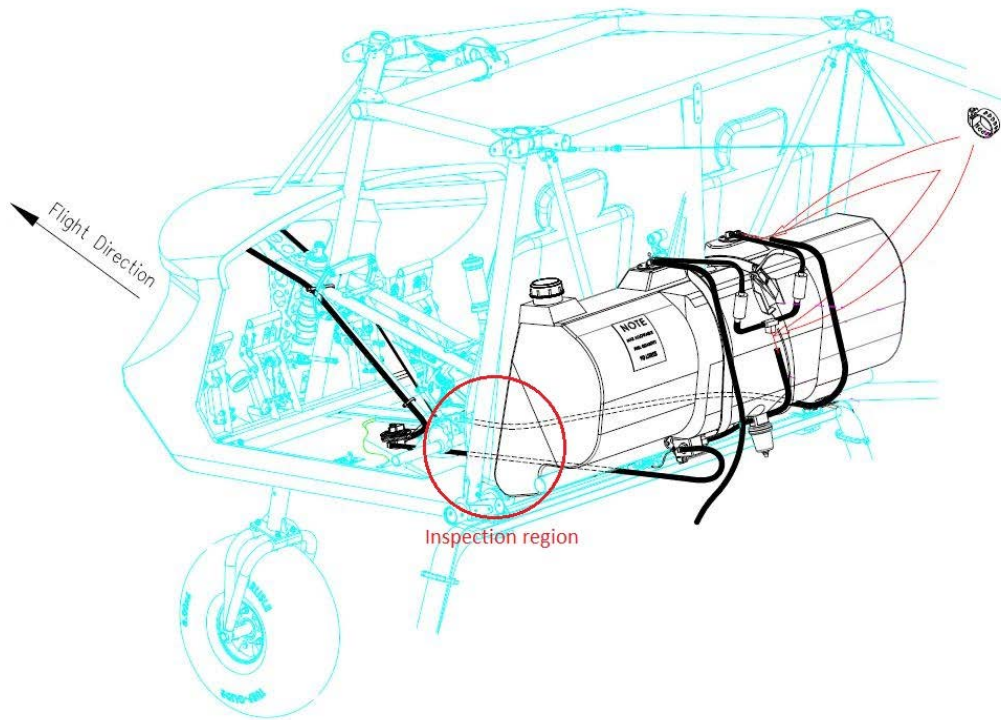
1. With the aircraft in a well lit area, open the doors and tip each backrest forward as far as possible.
2. With reference to figures 1, 2 and 3 below, inspect the fuel tank opposite the end of the bolt at the bottom of the seat and see if there is any visible indentation where the end of the M5 bolt protruding from the back of the back rest comes into contact with it.
3. In the presence of an adhesive rubber pad, inspect the pad to see if there is any erosion. If there is, establish if the fuel tank beneath has sustained any damage.

Figure 1: Schematic showing inspection region

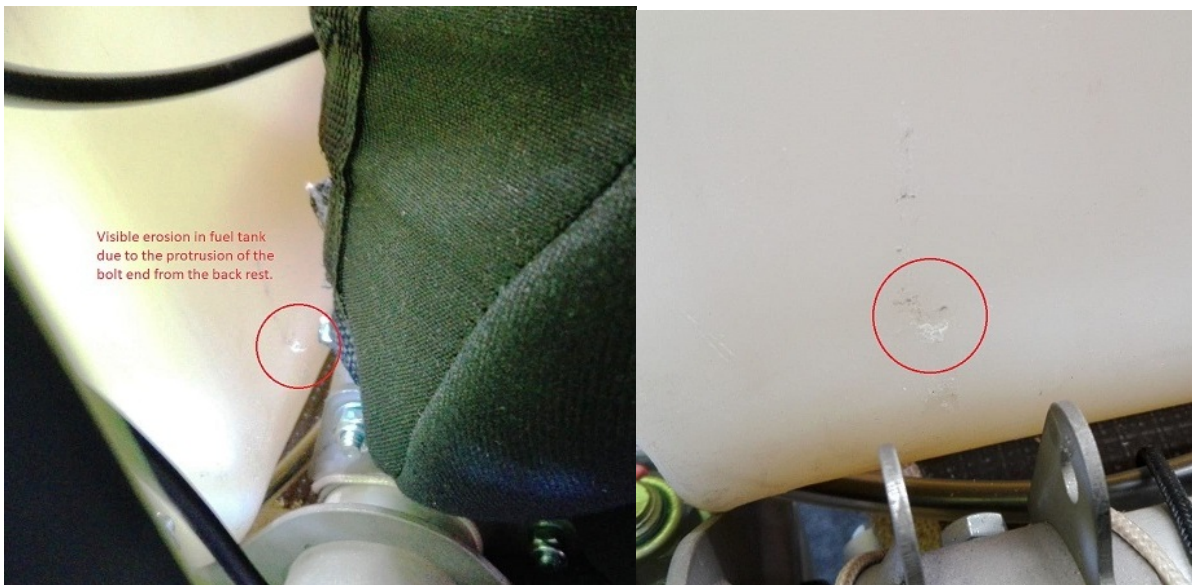
During the course of periodic maintenance inspections and pre-flight checks carried out on various aircraft; it was found in some aircraft that the aft end of the M5 bolt protruding from the bottom of the seat back rest was impinging upon the fuel tank and eroding away a section of the fuel tank.

Figure 2: Fuel tank showing eroded region

If the damage is to the fuel tank (either in the presence of or the absence of the adhesive rubber pad); a measurement must be taken to establish the depth of the eroded region in accordance with the procedure detailed below.

If the depth is less than 1.2 mm, notify the factory but continue to fly the aircraft while the factory responds with a permanent solution. An ongoing inspection of the depth of the eroded region needs to be carried out every 25 hours of flight in the interim.

If it is found that the depth of the eroded region exceeds 1.2 mm, notify the factory immediately and refrain from flying until the factory responds with a solution.

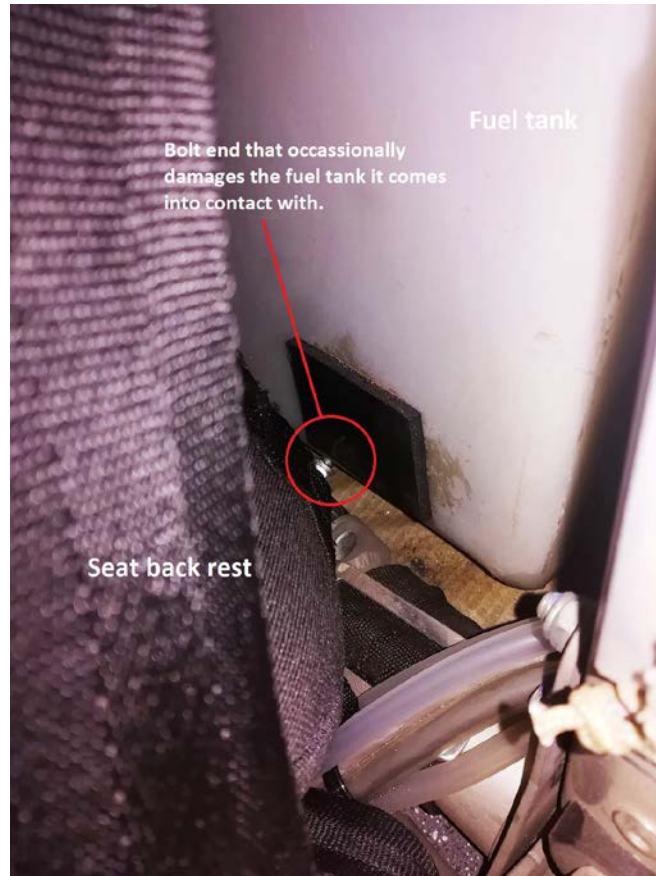
The necessity for this service bulletin came about firstly because some aircraft with the required geometry for the impingement of the bolts on the fuel tank were released without the adhesive rubber pad, and secondly because in some aircraft with the rubber pad present, the impingement of the bolt is sufficient to erode the rubber pad and then begin to erode the fuel tank beneath.

Figure 3: Detailed view of bolt protruding from back rest and coming into contact with fuel tank
