# Rainbow SkyReach (Pty) Ltd

## SERVICE BULLETIN

IMPORTANCE	HIGH
AREA AFFECTED	Engine Mount Adapter
SA/B NUMBER	CH 012 06-2019
EFFECTIVE DATE	25 June 2020

Inspection of the four M10 x 30mm bolts that attach the engine mount adapter to the engine mount.

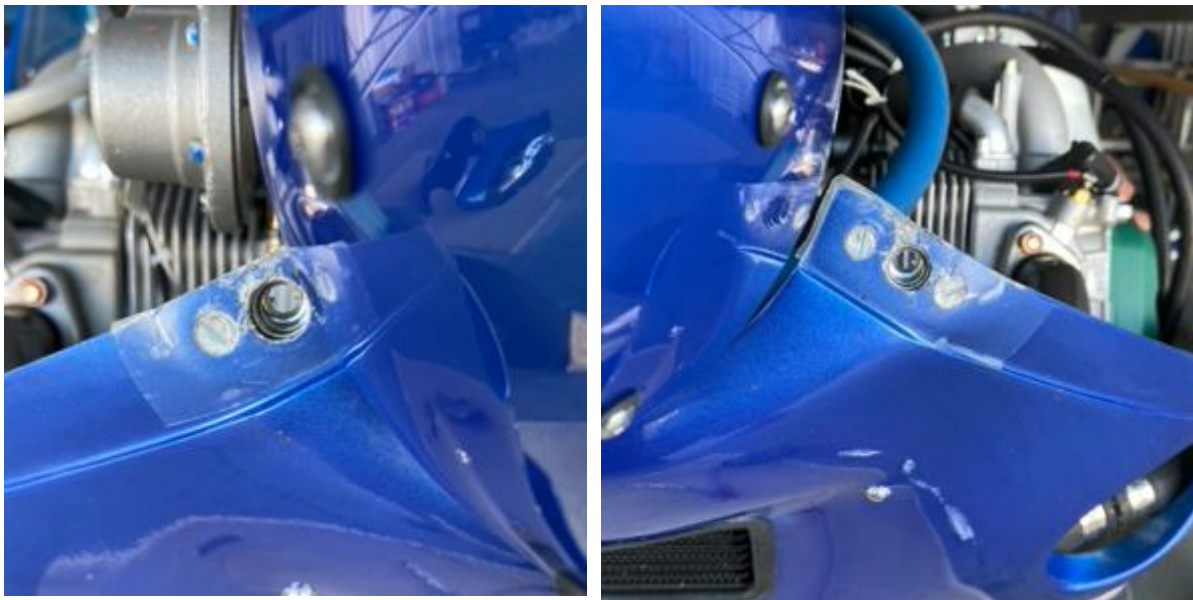
During the course of a pre-flight inspection on a kit-assembled aircraft with 50 hours total time, for which the parts were packed in May of 2017, it was noticed that the engine seemed to have shifted slightly to the right in the engine compartment. It was found that the rubber engine mounts were not properly seated in the engine mount which had resulted in the engine mount adapter and engine shifting slightly in the engine bay as can be seen by comparing the relative positions of the front DZUS fasteners on the cowling to the spinner in Figure 1. The engine had also shifted forward, resulting in the oil filter housing coming into contact with the lower oil radiator as shown in Figure 2.

Figure 1 – Engine shifted to the right

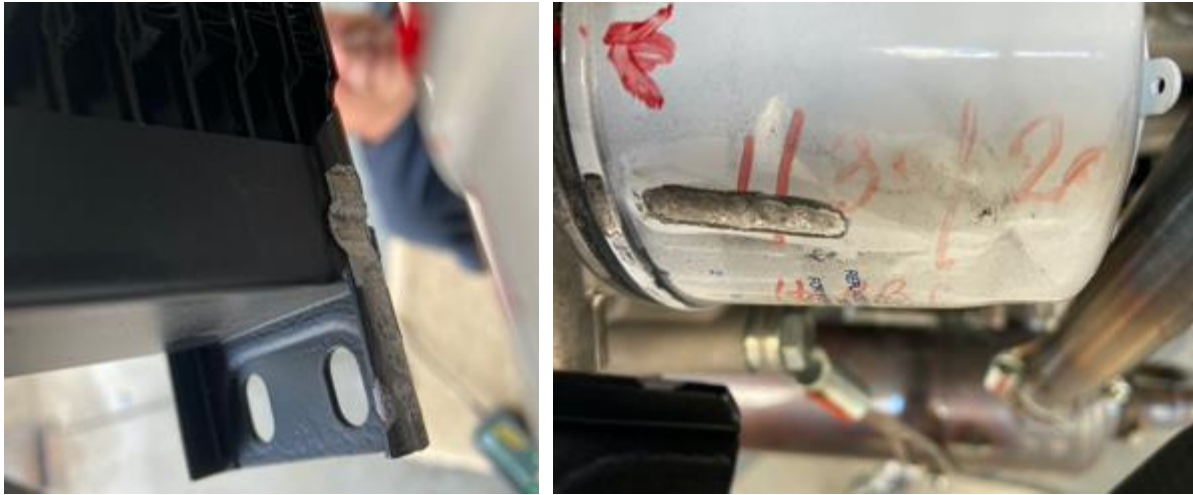
Figure 2 – Lower oil radiator and oil filter housing

Chaffing on the oil filter housing and the lower oil radiator will eventually develop into a catastrophic loss of engine oil which could result in an engine failure and/or an engine fire.

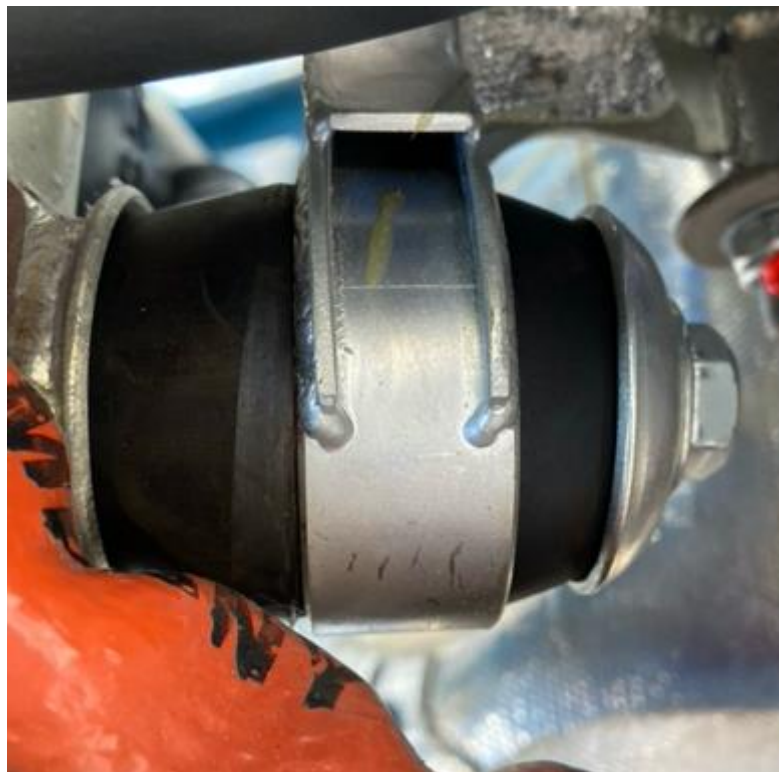
Upon further investigation it was found that the two lower engine mount adapter bolts were bottoming out prematurely in the engine mount adapter rods which in turn prevented the rubber engine mounts from being properly fastened and compressed, which allowed the rubber mounts to become unseated as can be seen in Figure 3.

Figure 3 – Unseated rubber mount

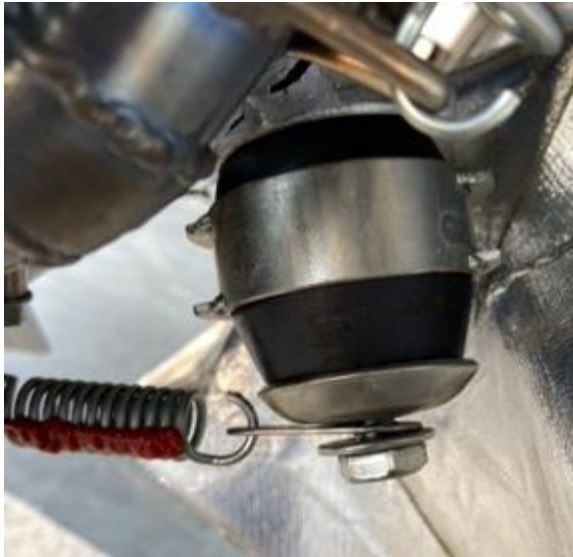
The bolts were bottoming out due to a manufacturing defect in the rods into which they bolt. One of the defective rods are shown in Figure 4 where it can be seen that the bolt is not completely fastened and some of the threads are visible, whereas in Figure 5 the correct mount is shown and it can be seen that the bolt is completely bolted in and no threads are visible.

Figure 4 – Defective mount rod

To circumvent the problem a shorter length, Grade 8.8 Zinc Plated M10 bolt may be used which would not extend past the threaded section in the rod and would therefore not bottom out. At the time of publishing this service bulletin it had not been determined whether a M10 x 25mm or a M10 x 20mm would be the best replacement option. The factory will supply the best replacement option at no cost to the operator, we recommend using only approved bolts supplied by the factory since we cannot guarantee that the material and geometrical properties of your local hardware store bolts will be correct.

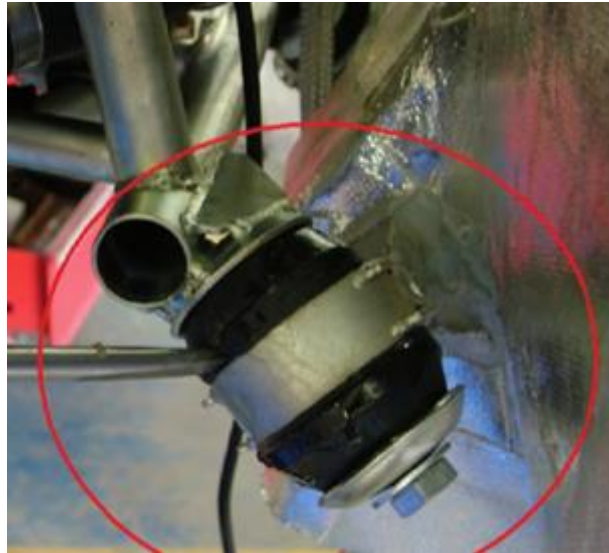
Figure 5 – Correct mount rod

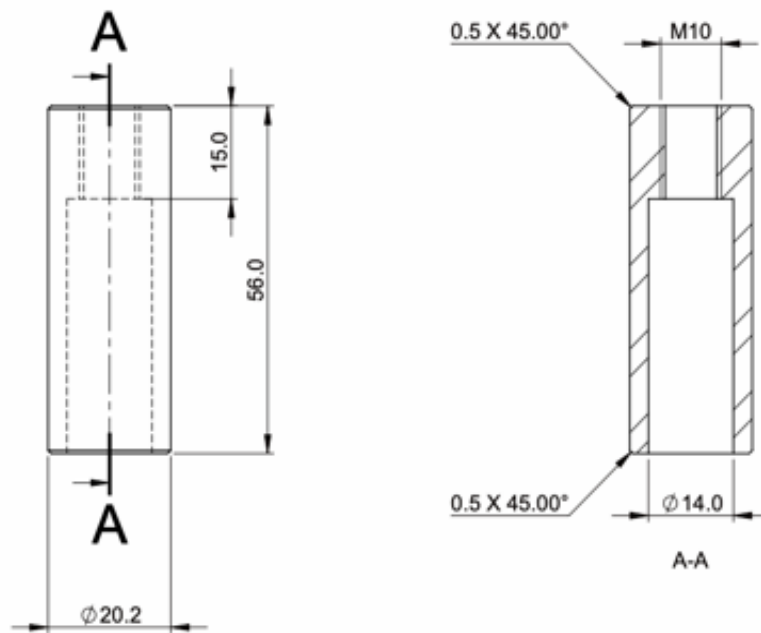
The reason for the bolt bottoming out and not fastening fully is due to a manufacturing defect in the machining of the rod before it gets welded to the rest of the adapter. For clarity a drawing of the rod is provided in Figure 6. The part is manufactured by drilling a  $\text{Ø}8.9\text{mm}$  hole through the entire rod. The first 15mm is then threaded, and a larger  $\text{Ø}14.0\text{mm}$  hole is machined in from the other side up to where it makes contact with the threaded section. In defective mounts the  $\text{Ø}14.0\text{mm}$  hole's depth was incorrect and it does not reach the threaded section, as a result the bolt cannot extend past the 15mm threaded section.

Figure 6 – Engine mount adapter rod

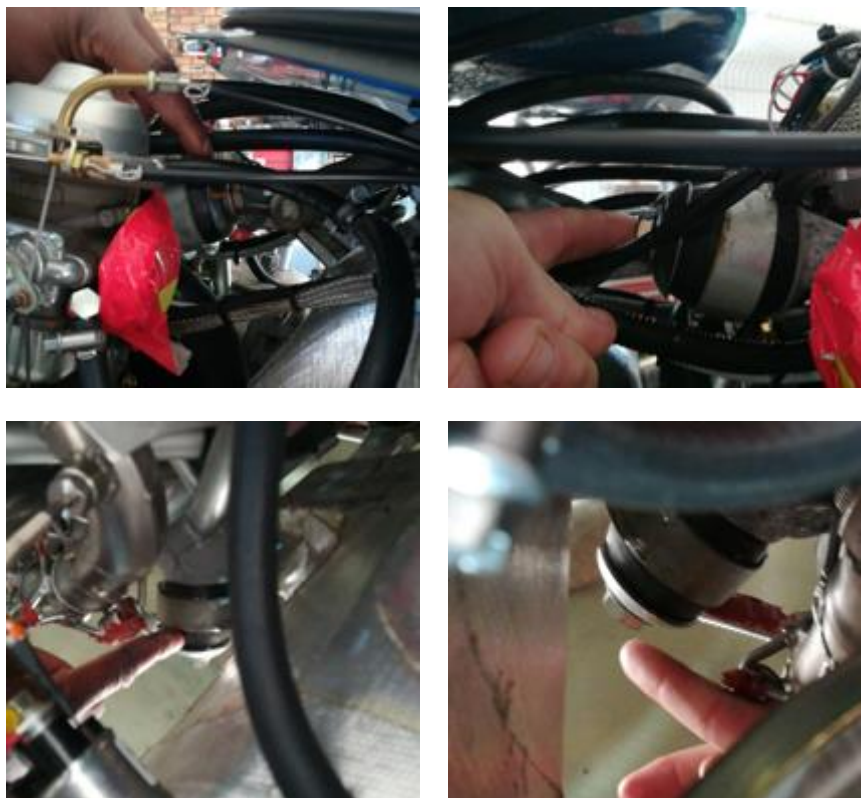
Figure 7 – Bolts requiring inspection

1. All aircraft must be inspected visually by the operator before further flight. Steps 2 and 3 are only symptoms of the problem and if any of those two checks hold true, step 4 will still need to be checked to confirm that a defective engine mount adapter rod is the cause.
2. Check for a noticeable lateral shift in the engine by comparing the location of the front DZUS fasteners to the spinner.
3. Check for the oil filter housing chaffing on the lower oil radiator.
4. Check visually for any of the four engine mount adapter bolts which are not properly fastened, visible threads under the bolt head, as in Figure 4, would indicate that this is the case. The bolts to inspect are shown in Figure 7.

5. If a defective mount has been identified the factory should be notified immediately and the aircraft is to be grounded until the problem has been addressed.

The two lower bolts may be removed as is, you may just have to remove the lower cowling to gain access to the engine mount. The upper bolts are slightly more complicated since the weight of the engine would need to be fully supported on an appropriate engine hoist before loosening the top bolts.

When inserting the new bolts ensure that the washers (and exhaust plate for the lower mounts) are inserted back in the same order that they were in when removed.
