Rainbow SkyReach (Pty) Ltd

SERVICE BULLETIN

IMPORTANCE	HIGH
AREA AFFECTED	PITOT TUBE
SA/B NUMBER	CH 014 10 2020
EFFECTIVE DATE	21 OCTOBER 2020

Inspection of the pitot tube to determine if pitot static ports are or are not present.

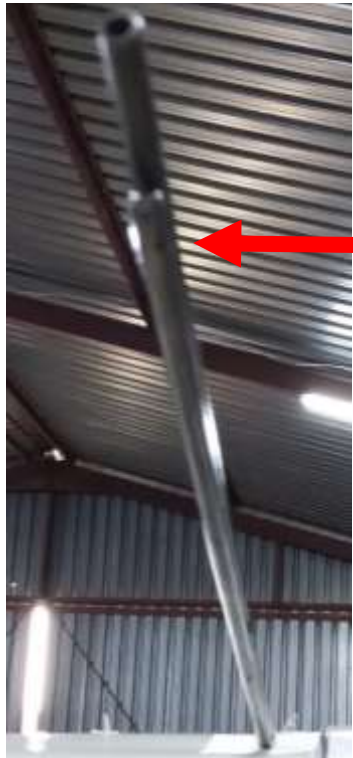
Figure 1: Location of static ports (on lower tube)

1. All aircraft pitot tubes must be inspected visually before further flight and it must be determined whether the tubes have static ports or not. See the following figures to describe where the 2 ports may be found. Note that they are small, so care must be taken to look in a well-lit area, and closeup. If ports are present, the aircraft can be flown as normal without any further need for action.
2. If the static port holes are not found, no further flight must be performed on the aircraft, and the factory/distributor must be contacted and informed immediately.

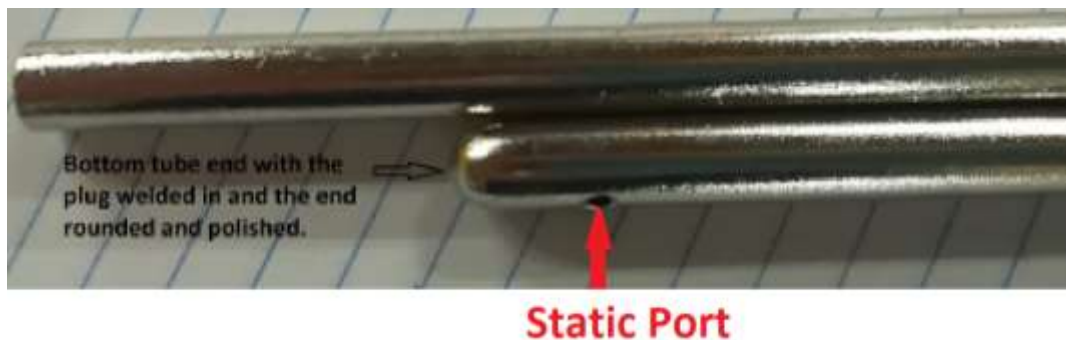
Figure 2: Close-up of static port (one visible, not installed on aircraft)

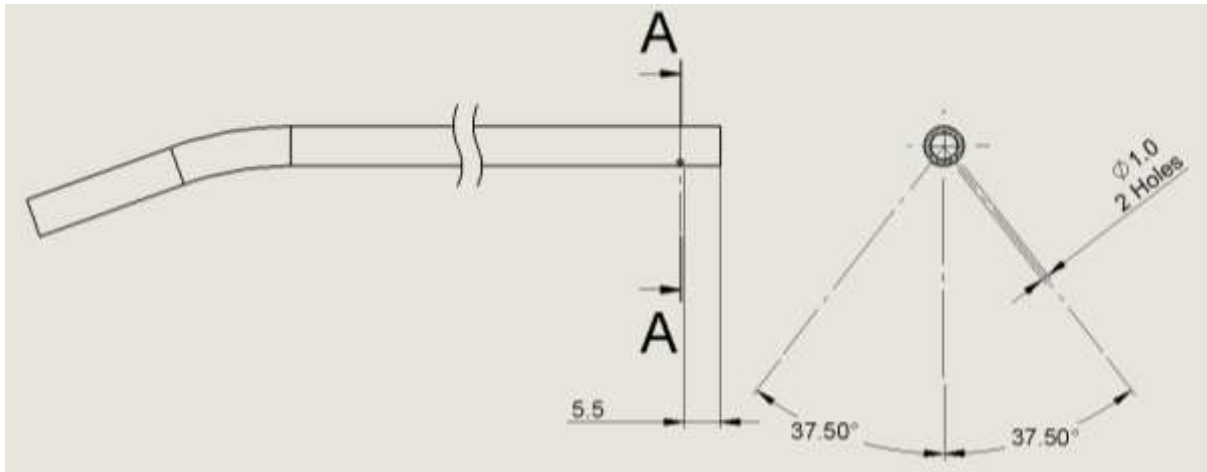
Figure 3: Section and broken view of drawing showing static port locations (endcaps not shown)
