Rainbow SkyReach (Pty) Ltd

SERVICE BULLETIN

IMPORTANCE	NORMAL
AREA AFFECTED	LANDING GEAR
SA/B NUMBER	CH 015-05-2021
EFFECTIVE DATE	5 MAY 2021

Inspection of the radius block installation bolts to ascertain the position quantity of washers.

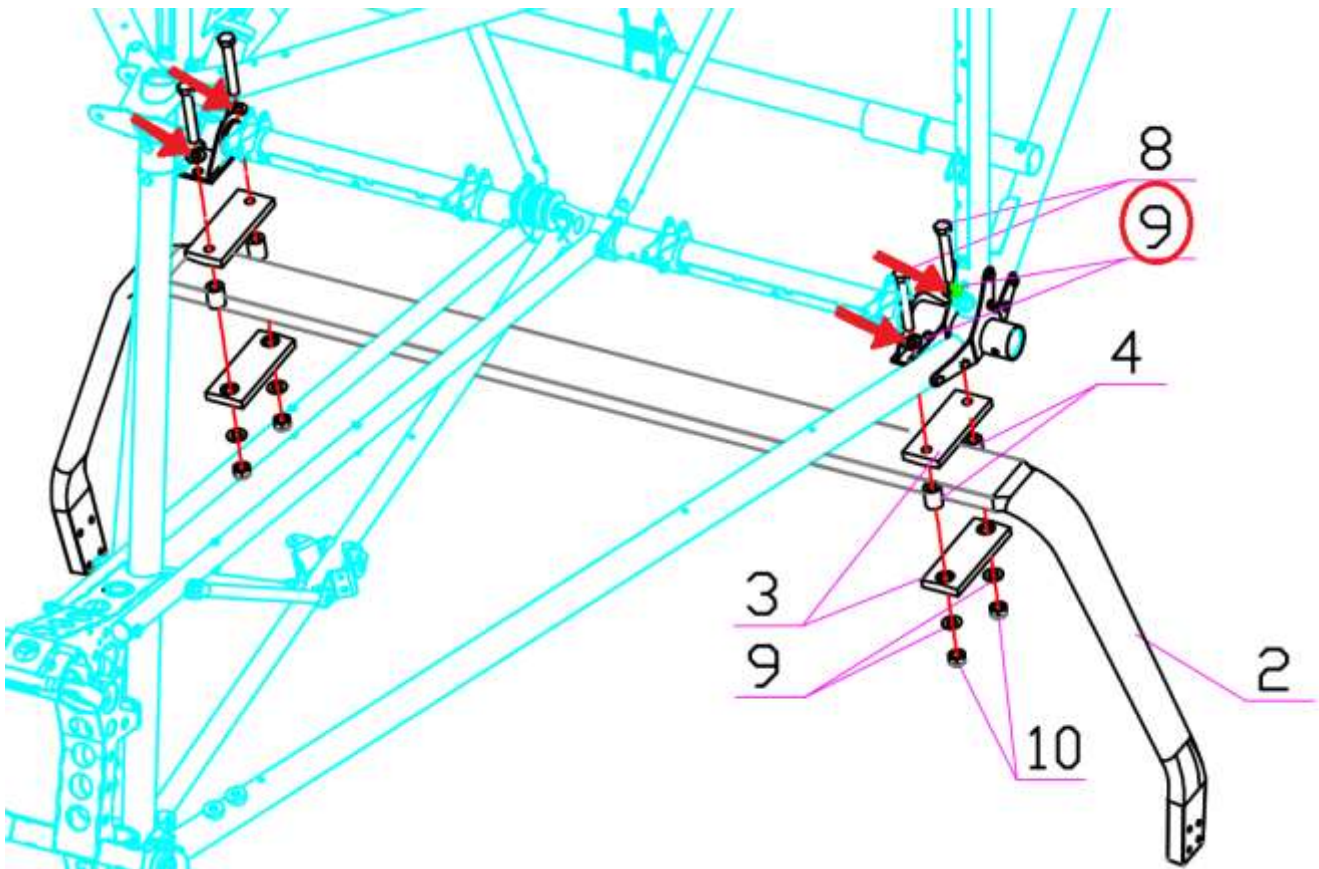
Figure 1: Correct Washer Location

During a kit build, it was discovered that the locations shown in the manual for the washer installation were incorrect for one step of the assembly process. This could lead to incorrect loading of the washer and bolt.

The specific washers that this document refers to, if missing, will simply mean that the bolt head is directly against the bracket, which is no concern due to the bolt and bracket being sufficiently specified to deal with the loading. In the case of the washers being incorrectly located, the forces due to tightening will mean that everything is still tight, but in addition to the bolt head being against the bracket, the washer between the bracket and radius block may mean the washer could start to slightly notch the radius block, but not in a dangerous way if rectified at the next maintenance interval.

1. All the relevant aircraft radius block assemblies must be inspected at the next maintenance or inspection interval. This can be done before then if the pilot desires. With reference to Figure 1, the washers should be located with one between each bolthead and the bracket, and then one between the lower radius block and the Nyloc nut. This applies to all 4 of the bolts, i.e. 8 washers in total. These are shown by the label '9' in the figure, and the ones that might be incorrectly installed/missing are shown with arrows. Look to see if there are washers installed above the upper radius block between it and the bracket above.

2. If the washers are all in place correctly, with no additional ones, no modification is needed. If there are extra, missing, or incorrectly installed washers, please contact the factory/distributor and tell them the findings, and request the BCUG-083 upgrade kit which will provide the parts and instructions on how to correct the installation.
