# Rainbow SkyReach (Pty) Ltd

## SERVICE BULLETIN

IMPORTANCE	INFORMATIONAL
AREA AFFECTED	Throttle System Maintenance
SA/B NUMBER	CH 017-07-2022
EFFECTIVE DATE	22 July 2022

Advisory to ensure correct throttle movement and behaviour.

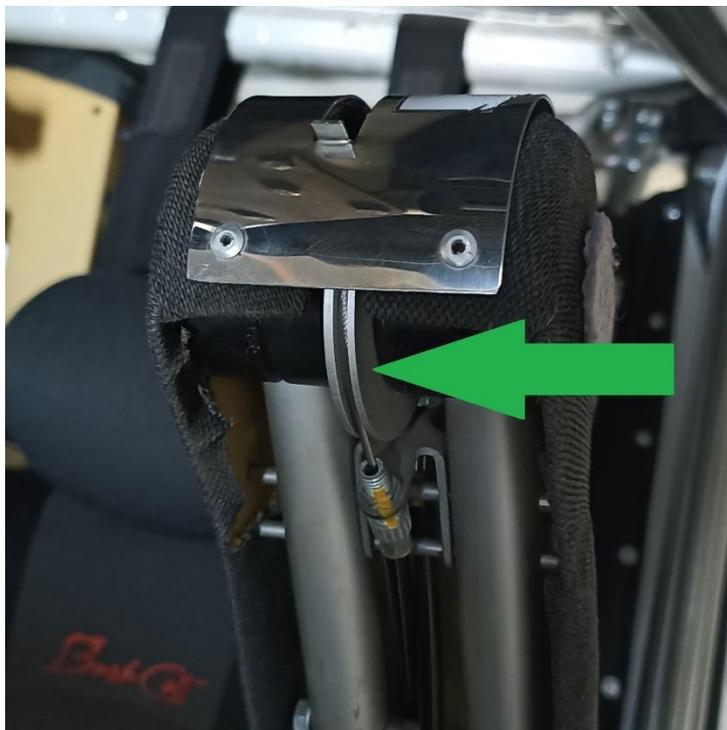
It has been seen on one old aircraft used in flight training, manufactured with the Nylotron pulley, that the Nylotron actual wore away on one side, resulting in the crimp and cable having some play in the groove. This means that the throttle lever on that side does not control the actual throttle as directly as it should. The second throttle lever (on the other side of the aircraft) still functioned fully as long as firm control input was applied. This means that control from the side with the faulty throttle pulley is compromised.

Before further flight, the aircraft owners should first check if their aircraft is even potentially affected. This is done by simply lifting up the armrest and looking at the pulley. Figure 1 shows a raised armrest, and has the pulley circled. Note that this is an aluminium pulley (and this aircraft would therefore not be affected). The Nylotron version of a pulley would be in the same location but would be coloured black.

Figure 1: Pulley Identification (Aluminium disk with Groove at Arrowhead)

If the pulley on the owner's aircraft is aluminium, this advisory can then be ignored. If it is Nylotron, please follow the remainder of the procedure.

1. Simply cycle each throttle lever through its full range, closed to open to closed again. Do each side independently, while watching the opposite to side to observe response.
2. If the throttle does not respond/has abnormally high resistance, or the other side does not move in sync with the side being operated, or the other side jumps or responds with a delay, the throttle pulley may be worn/damaged. In this case, the aircraft should be inspected by a qualified aircraft mechanic, or the factory should be contacted immediately before any further flight.
3. If both throttles move normally and in sync, without any significant resistance or abnormal behaviour, the aircraft can be flown as normal.
