Rainbow SkyReach (Pty) Ltd

SERVICE BULLETIN

IMPORTANCE	MANDATORY
AREA AFFECTED	Throttle System Maintenance
SA/B NUMBER	CH 018-10-2022
EFFECTIVE DATE	14 October 2022

Advisory to ensure correct throttle movement and behaviour.

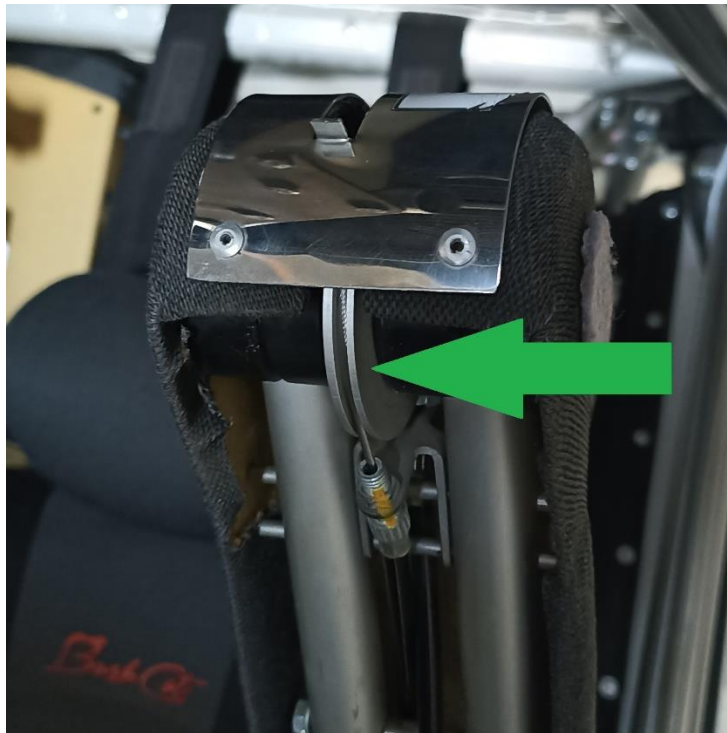
Figure 1: Pulley Identification (Aluminium disk with Groove at Arrowhead)

It has been seen on one old aircraft used in flight training, manufactured with the Nylotron pulley, that the Nylotron actual wore away on one side, resulting in the crimp and cable having some play in the groove. This means that the throttle lever on that side does not control the actual throttle as directly as it should. The second throttle lever (on the other side of the aircraft) still functioned fully as long as firm control input was applied. This means that control from the side with the faulty throttle pulley is compromised.

Before further flight, the aircraft owners should first check if their aircraft is even potentially affected. This is done by simply lifting up the armrest and looking at the pulley. Figure 1 shows a raised armrest, and has the pulley circled. Note that this is an aluminium pulley (and this aircraft would therefore not be affected). The Nylotron version of a pulley would be in the same location but would be coloured black.

If the pulley on the owner's aircraft is aluminium, this advisory can then be ignored. If it is Nylotron, please follow the remainder of the procedure.

1. Simply cycle each throttle lever through its full range, closed to open to closed again. Do each side independently, while watching the opposite to side to observe response.
2. If the throttle does not respond/has abnormally high resistance, or the other side does not move in sync with the side being operated, or the other side jumps or responds with a delay, the throttle pulley may be worn/damaged. In this case, the aircraft should be inspected by a qualified aircraft mechanic, or the factory should be contacted immediately before any further flight.
3. If both throttles move normally and in sync, without any significant resistance or abnormal behaviour, the aircraft can be flown as normal.
