Rainbow SkyReach (Pty) Ltd

SAFETY DIRECTIVE

IMPORTANCE	HIGH
AREA AFFECTED	SEAT-BELT
SA/D NUMBER	CH 016-11-2021
EFFECTIVE DATE	5 November 2021

Inspection of the shoulder segment joining of the seatbelt for fraying/unravelling.

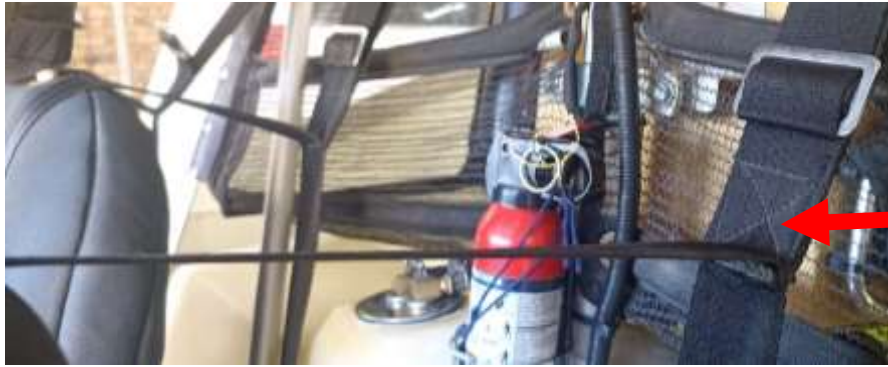
All BushCat/Cheetah XLS aircraft with serial number lower than CH-277C, with the 'X' style stitch pattern (visible in Figure 1). Belts with the new stitching pattern (visible in Figure 2) can ignore this directive.

1. To aid in the inspection, push the backrest of the seat forward, as this will help show the area of concern.
2. Inspect the area of the join of the vertical segment of the seatbelt, and the shoulder-harness section that runs (almost horizontally, when the backrest is pushed forward) over and down the seat (see Figure 1).

- a. Inspect the general quality of the stitching for any signs of fraying or unravelling of the stitching that joins the belt sections.
 - b. From below, inspect the join area where the shoulder-harness section moves horizontally away for separation. This is the critical area of failure (see Figure 3).

Figure 1: Belt Pulled Horizontal by Seat being pushed Forward
(Stitching area to inspect shown by red arrow)

3. If the belt is in good condition, without signs of fraying or separation, the aircraft can be flown as usual. The inspection step should be repeated as part of every preflight inspection.

4. If there are signs of fraying and/or separation, please contact your distributor/the factory immediately in order to obtain a replacement seatbelt, and do not fly in that seat until the part has been replaced.

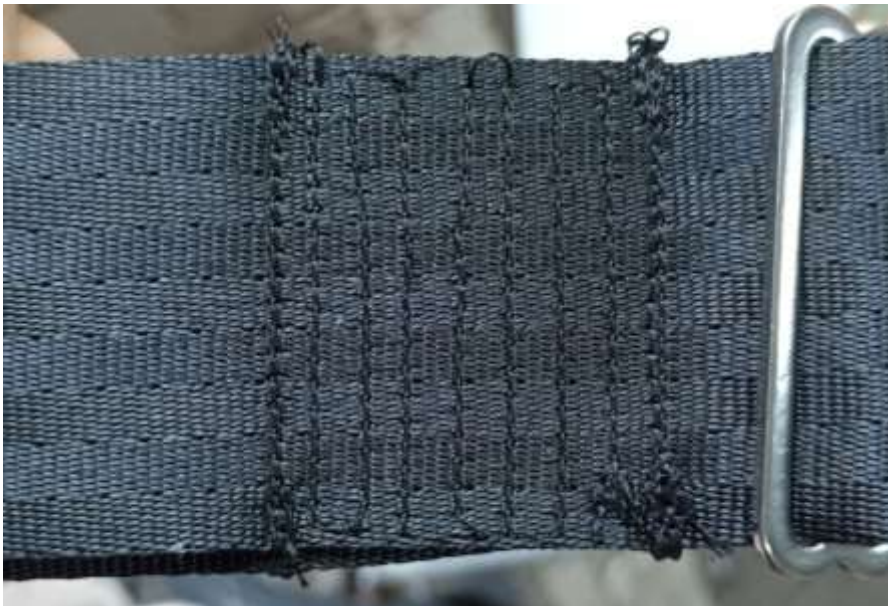
Since this possible issue was brought to our attention, an improved method of stitching the affected area on the shoulder harness has been incorporated into our manufacturing methods. This is shown in **Figure 2**.

Figure 2: New Stitching Pattern

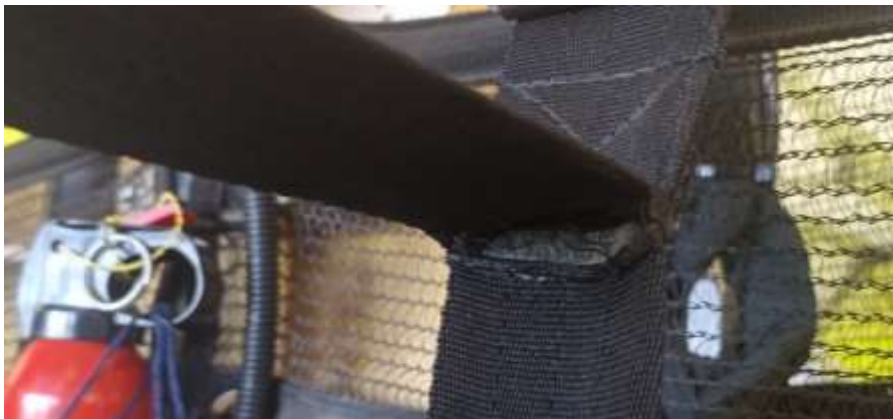
Figure 3: Belt Separation Visible from Below
