Rainbow SkyReach (Pty) Ltd

ALERT SERVICE BULLETIN

IMPORTANCE	High
AREA AFFECTED	Packed Parachute Assembly
SB NUMBER	CH/005/04-2018

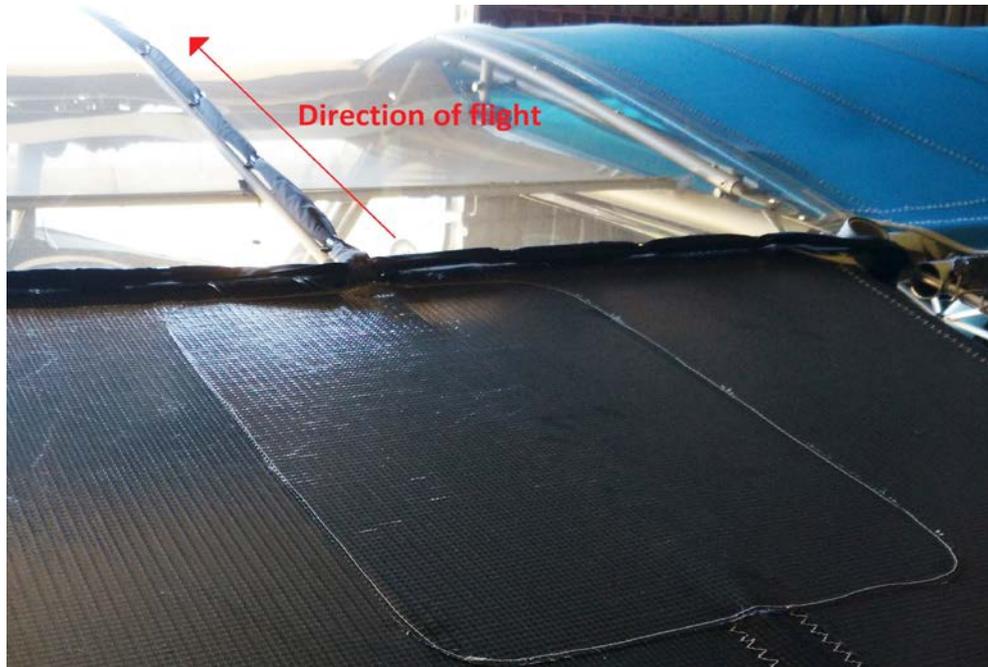
Figure 1: (a) Egress panel cut out 1

- Aircraft with Egress panel cut out 1 **and** BRS system installed (see figure 1(a)).
- All aircraft with Egress panel cut out 2 **or** no installed BRS system are not affected (see figure 1(b)).

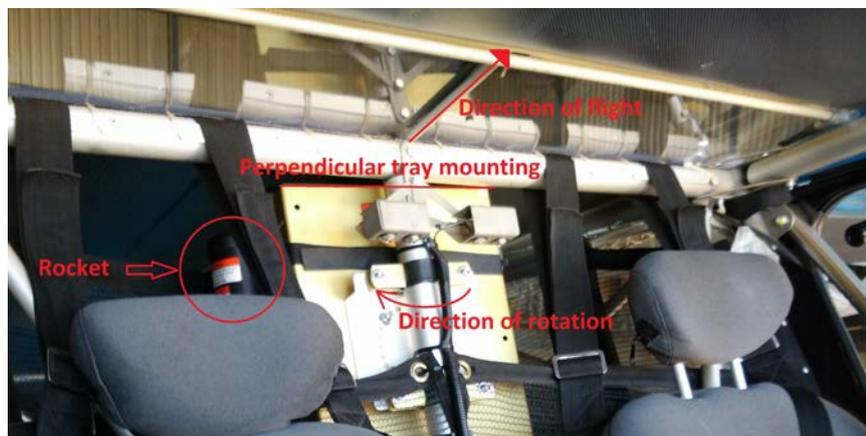
Step 2

Rotate the parachute assembly on the support strut clockwise (looking downwards from a top view) until the rocket sits underneath the trilam egress panel.

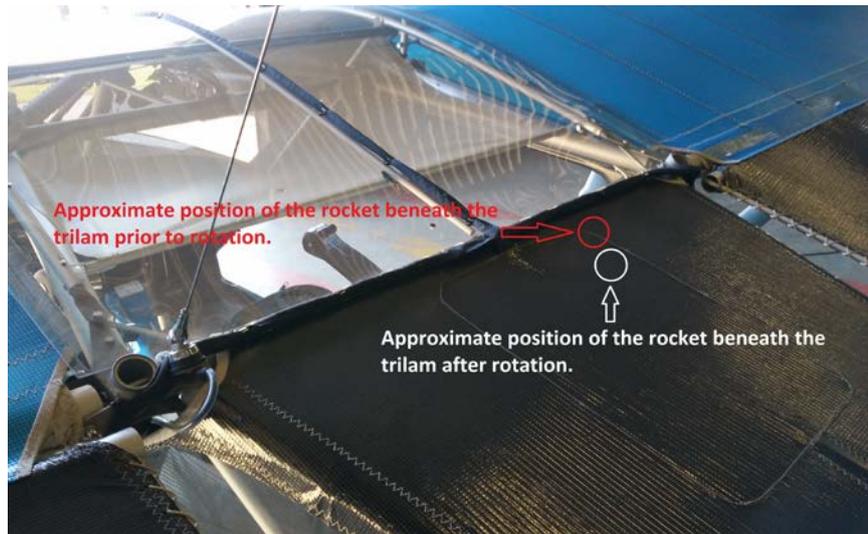
Step 3

Press lightly on the trilam from the top while a second person supports the parachute assembly against the support strut to check that the rocket sits beneath the egress panel beneath the trilam as shown.

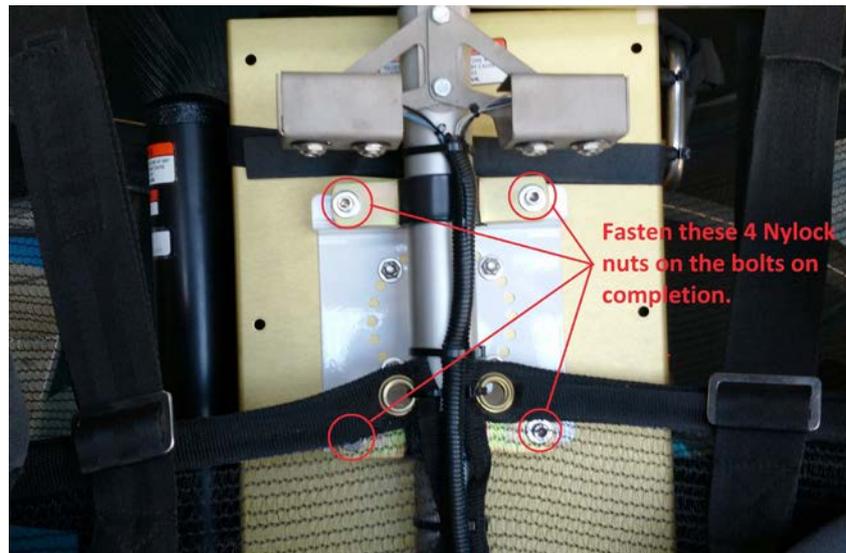
Step 4

Tighten all 4 Nylock nuts on the 4 bolts on the mounting brackets to secure the parachute assembly back to the support strut in the new position.

It is once again advisable to have a second person supporting the parachute assembly while the first person tightens the nuts once more.
